# CLINICAL CASE REPORT

## Pressure redistribution and stability through immersion on an Adjuster 12.

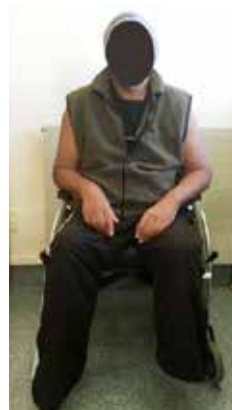
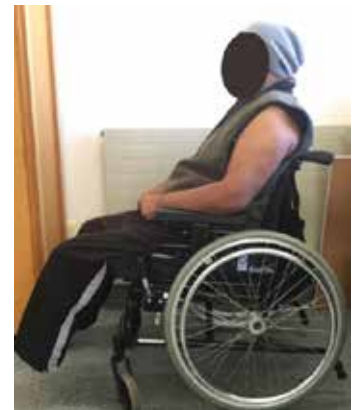
- The wheelchair cushion did not afford Mr. S. sufficient pressure redistribution as he indicated a sitting tolerance of approximately an hour. After which he would experience pain under both ischial tuberosities (Its) and in his sacral region. Despite being able to weight shift independently he could not sit in his wheelchair comfortably all day and needed to switch to different surfaces to reduce discomfort.

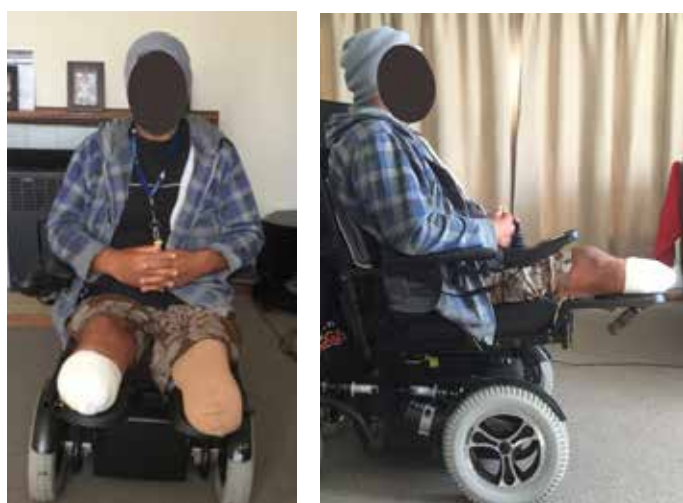
Mr. S. is now comfortably using his new powered wheelchair with the Vicair Adjuster 12 and nxt backrest. He is able to remain in his wheelchair comfortably for the duration of the day. He can now use his wheelchair without the risk of pressure and shear related injuries. The new configuration allows him to safely and independently access his home and community.

The Adjuster 12 provides Mr. S. with high pressure distribution properties that are needed to enable him to sit safely and comfortably all day. The pre-ischial bar prevents him from sliding forward, whilst deep immersion provides stability. Furthermore the cushion is low maintenance and easy to understand. The Vicair Adjuster 12 turned out to be the ideal product choice and solution for Mr. S.
